Adaptive Reuse of Ankara CerModern Art Gallery Evaluation of Structural System

*CerModern,
Industrial heritage,
Adaptive reuse,
Structural system
Intervention*

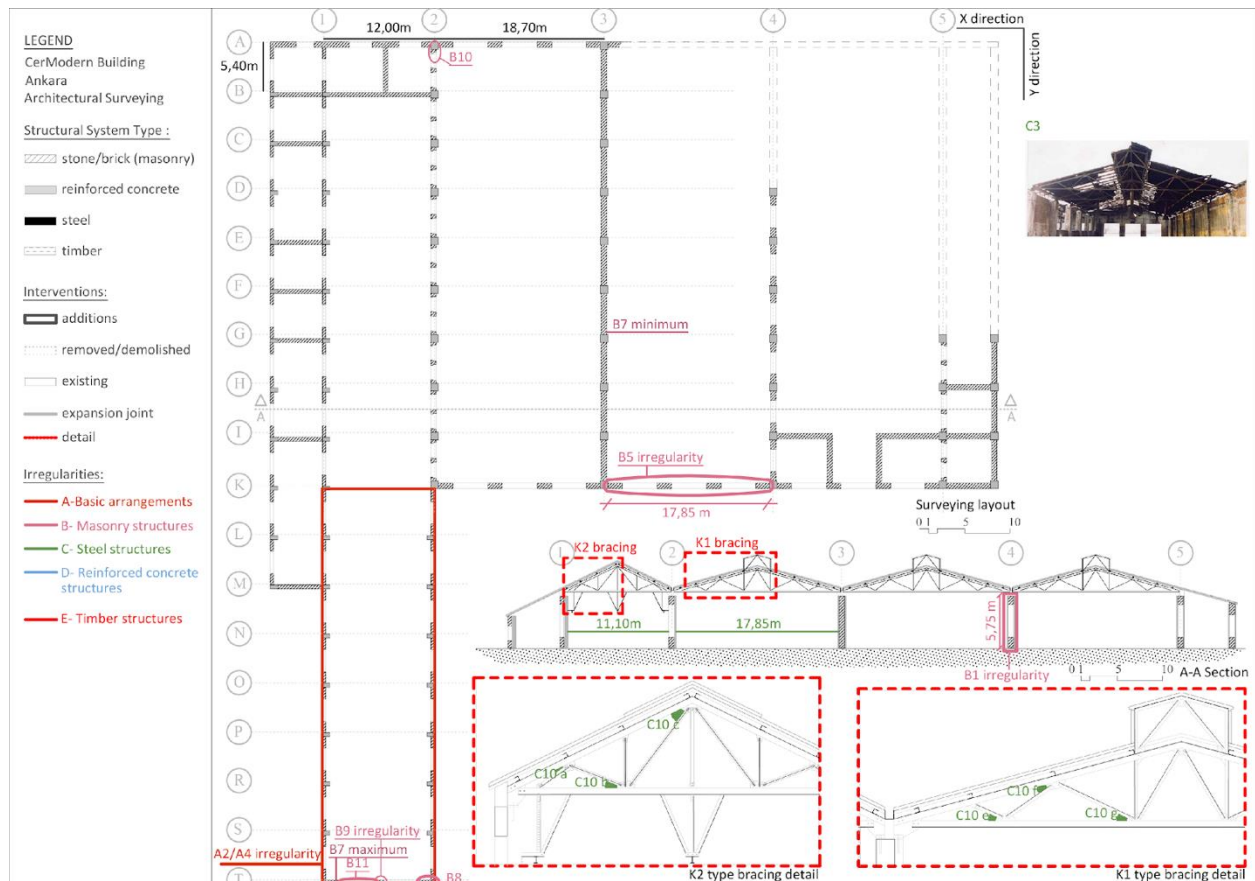
Figure 3. Architectural surveying before architectural restoration, drawings of CerModern

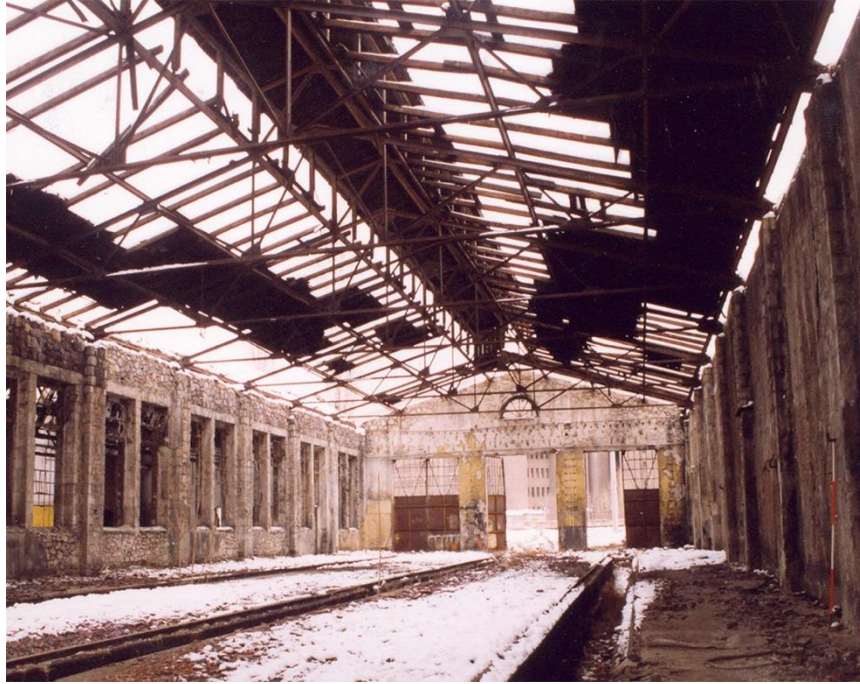
The hangar roof trusses (1,2,3) have similar features and dimensions, and the height of the truss beams is at safe level according to the span. In the fourth workshop (4), which is stated to have been built later, the truss opening is less, but the heights are close to the truss in other hangar roofs. Due to architectural concerns, it is thought that this provided continuity and order in the view by keeping the heights of the gable walls close to each other. There is not much change in the design of trusses except for the difference in truss spans (Figure 3). Triangle truss type was used with bolt connection. Although it is not known exactly when the building functions ended, it is known that it was in a devastated state and the roof trusses were largely corroded before it was restored (Figure 4).

Figure 4. The pre-restoration state of Hangar 1-2 (Uygur Architecture Archive, 2019)

It was stated that serious corrosion and material loss were detected in the steel members due to the long-term inactivity of the structure before the restoration, besides, there is naturally no precaution against fire in the members. It is understood that the collapsed and fatigue structural system members have adversely affected the continuity of the structural system. In the authentic truss design, it has been determined that the weld and rough bolt joints are not used together. In terms of truss beams and axle spacings, the ratio of axle spacing to truss beam opening is above the required ratio of 1/3 to 1/4 for both truss beam types. The ratio between the height of the truss beam and the span of the truss is by the limits determined in the design principles. According to these ratios, the truss design receives engineering services. The presence of horizontal wind and stability joints on the roof is positive for safety. Considering the angles between the web members, it has been determined as a positive feature that it is generally designed to stay at 30 degrees and above. Apart from this, the presence of masonry walls between the columns on which the steel trusses sit was determined as an important plus in terms of resistance to lateral loads.

In the architectural restoration works, due to the serious corrosion of the roof trusses and their cover, steel frame connections, truss type, and connection members were completely removed and rebuilt following the authentic roof. Although the roof truss beams were found to be positive in terms of dimensions and proportions, the decision to completely replace the problematic trusses caused by corrosion and renew them in the authentic state was implemented (Figure 6-7-8).

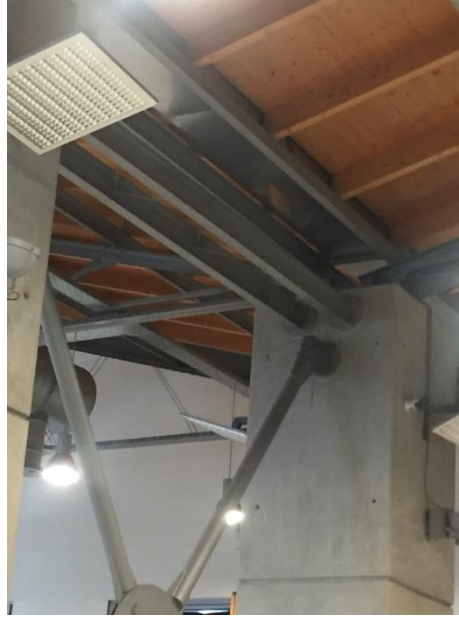
During the restoration, to ensure integrity in the hangar 1,2,3 and workshop (4) space all interior walls except the exterior masonry walls and the walls between the workshop-hangar sections were removed. However, in this case the lateral stability integrity of the frames has disappeared and the risk of not being able to meet the lateral loads such as earthquakes has emerged. As a solution to this problem, steel I beams and steel braces in some parts were added between all reinforced concrete columns (Figure 5). Interventions were made to the masonry walls where needed for protection.

Figure 5. Added steel I beam and braces

The fact that the internal load-bearing walls have been greatly decreased has greatly removed the effect of the masonry units, which initially contributed to the lateral drift of the structural system. This situation can be considered negative in terms of post-restoration building safety. Except for the facade walls, the other masonry walls retained after the restoration are thought to have been preserved as evidence of the building's history. The original masonry wall heights have been preserved. The values obtained by dividing the total lengths of the load-bearing walls in one direction excluding the voids by the gross floor area decreased further in the last case. However, it has been determined that measures have been taken for these negativities by means of steel beams and braces.

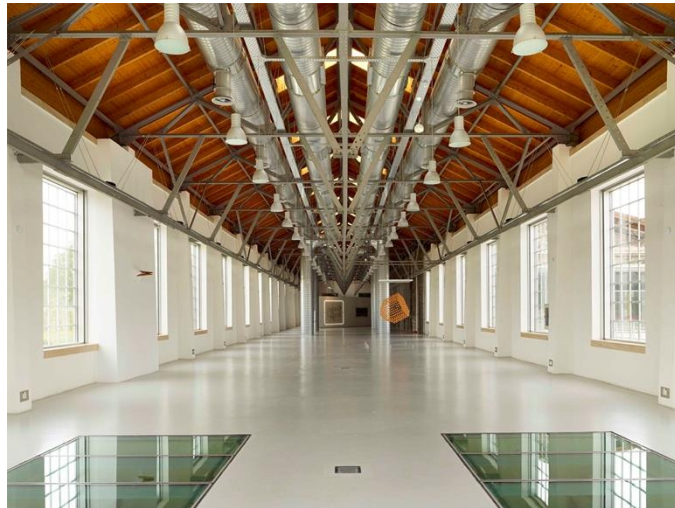
Figure 6. Post-restoration view of the hangar structure (Cemal Emden, 2010)

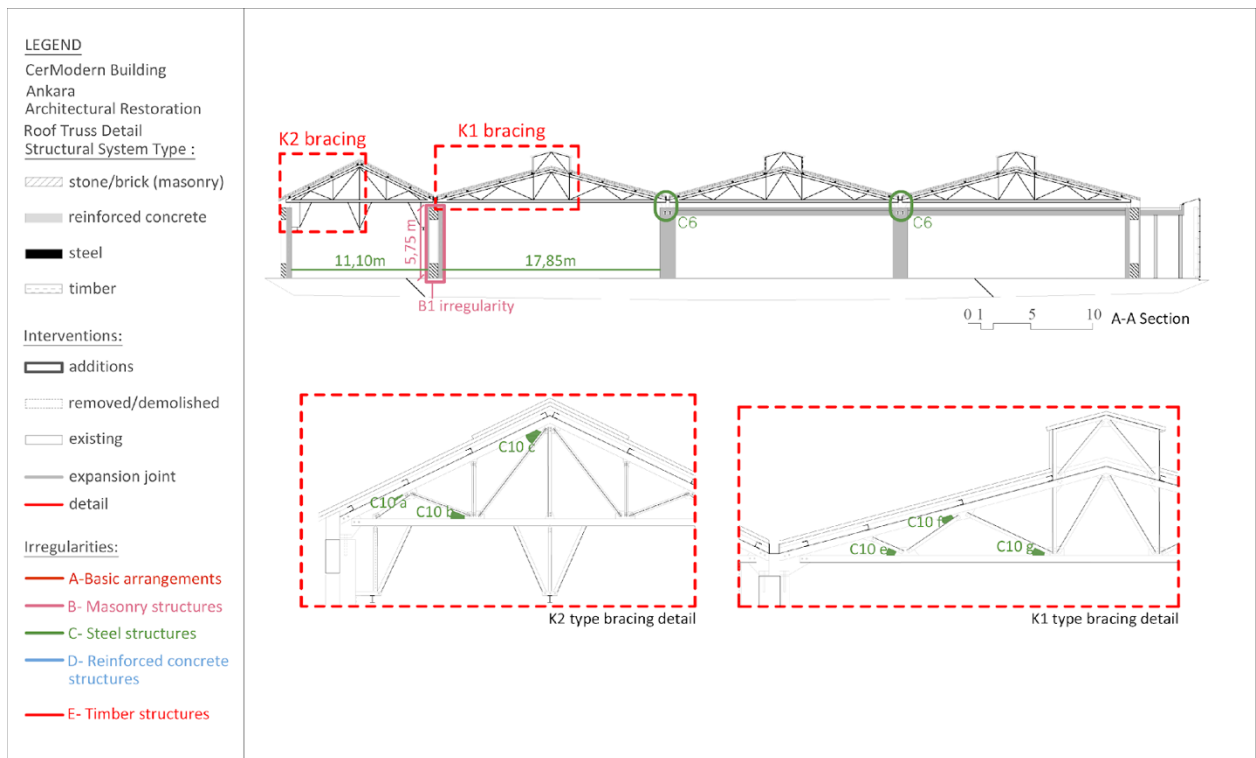
Figure 8. Restored truss details
