# Investigation of Architecture and Structural Deterioration Factors of Historical Kutahya Houses

Ahmet GÖKDEMİR<sup>1</sup>, Can DEMİREL<sup>2,\*</sup>, Çağlar KURT<sup>3</sup>

<sup>1</sup>Gazi University Faculty Of Technology Department Of Civil Engineering, Ankara

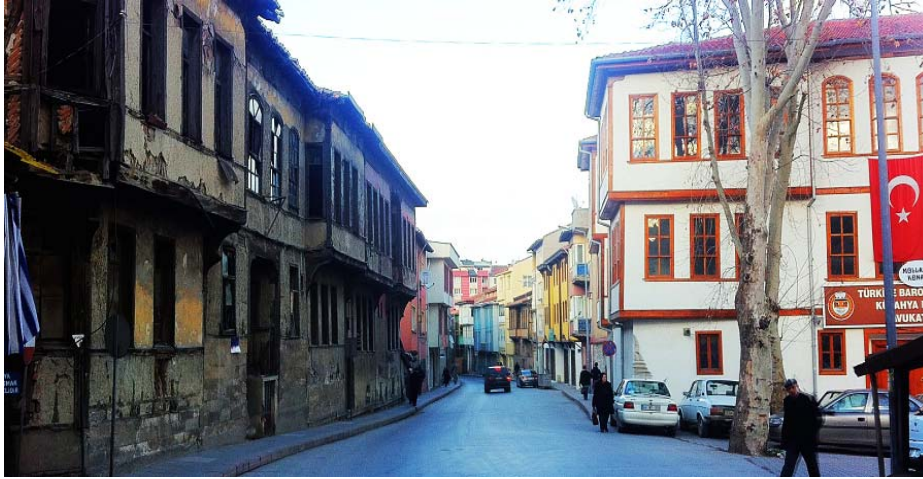
Figure 1. Street structure and the location of houses (writer archive, 2014)

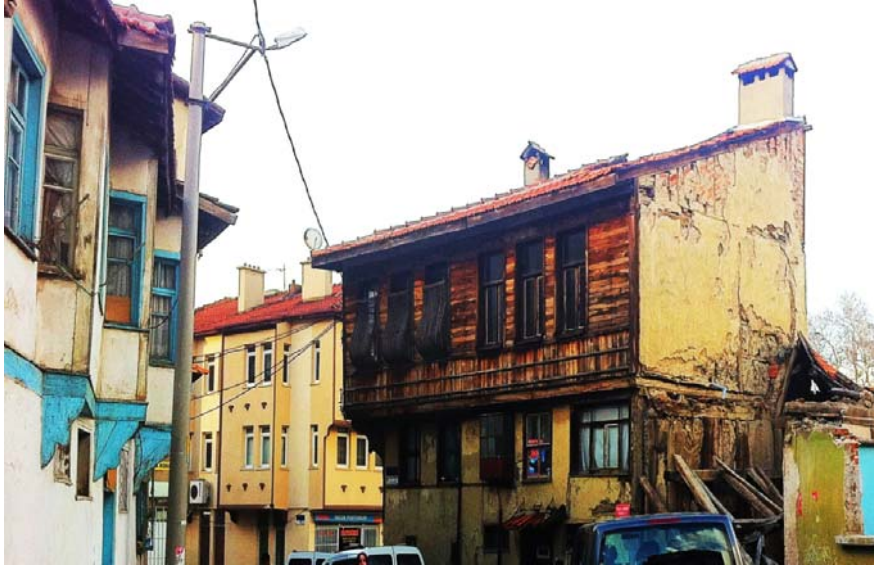
Wooden buttress outbuildings are the most important parts of Kutahya's houses. They are gradually in three floors and represent the desire to be outside. They are also convenient for perception of streets as vertical. In 19<sup>th</sup> and 20<sup>th</sup> centuries in which people preferred middle or inner sofa style, they used mostly window frame, eave, framing and bay window buttress for outside decoration more than inner one [2].

**Figure 2.** Buttress and outbuildings wooden houses (writer archive,2014)

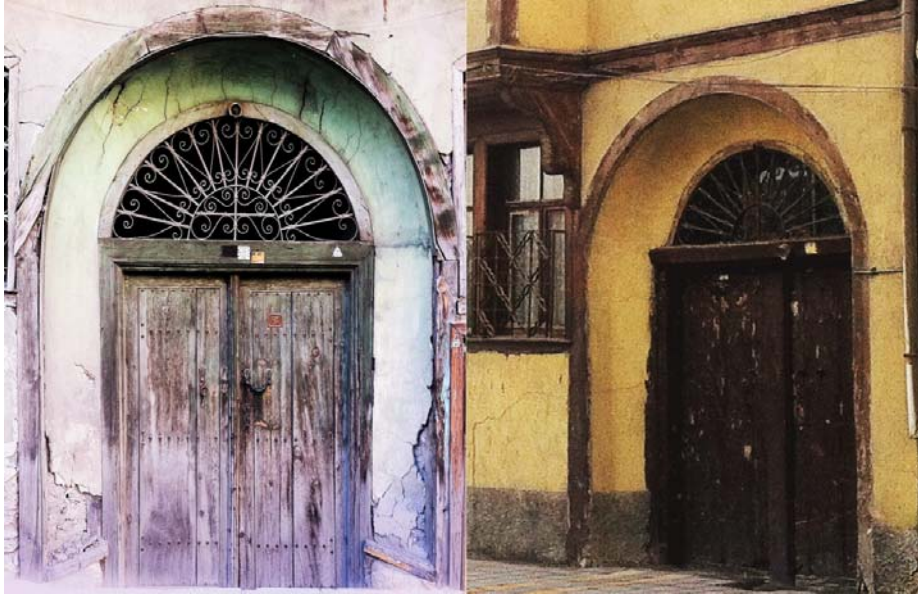
**Figure 3.** Double-leaf wooden and arched doors (writer's archive,2014)

Doors enable people to come in and be protected from outside. Windows are eyes of houses, and doors are like a mouth that is opened to outside for friends and stop enemies. People can come into houses mostly by using a street door and crossing the garden. House street doors are only decoration of buildings. Doors are usually double-leaf. They are on a wall reinforced with bonding timber, plastered with adobe, whitewashed, covered mostly with adobe and some stone. The duty of arc is not just to determine hinge and also to provide a basis for tri-serial drop nails. It prevents wings from changing shape. Interior doors are single-leaf doors. The duty of door wings is to save doorway. They are usually small. Most doors are opened to bottom of terrace. They all have sill. When the door wing is opened, it is provided that door is opened to area left inside of wardrobe width because people wanted inside of rooms not to be seen. There are mirrors and interlaced doors in Kutahya's houses. Even though there is much care and effort on the life's side, they have a rough appearance on the interior sides [2].

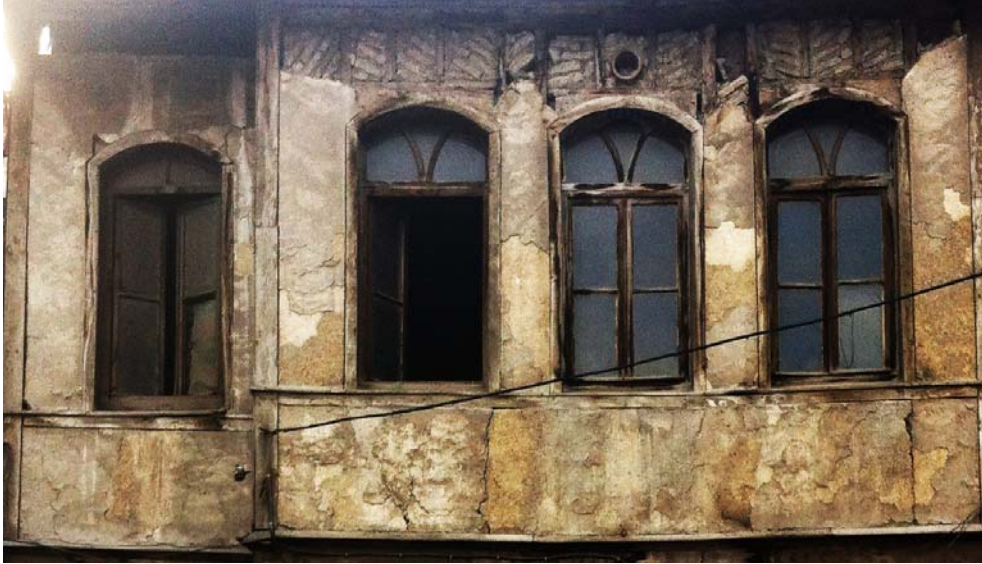
It is important that windows can be opened in several directions in empty rooms. Therefore, room is airy and gets sunlight, has a good fine view. Windows in the rooms are sorted in according to certain gaps. They are thin and long. There are frequent intervals between them. Since glass was very expensive in that time, windows were divided to 2-4-8 sections. People could use small pieces of glass when windows were broken [2].

**Figure 4.** Sectional windows (writer's archive, 2014)

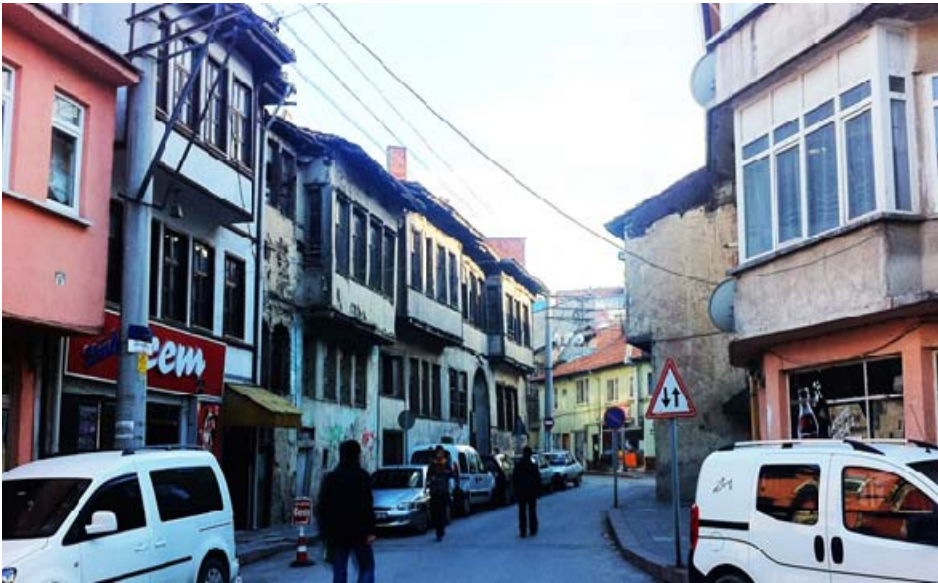
Row housing on both sides of the Street, the way that bay windows do not obscure each other and do not disturb other residences' windows enable neighbourhood relations to come to an agreement. The merits of respect, cooperation and love of neighbourhood relations play an important role in the shape of the street. Generally, the ground floor of the house but on the upper floors they go beyond their houses with the bay windows that provide them with a larger sight. Sometimes, eaves are about to touch each other but still do not prevent the sight of houses from the layout of row housing. The streets, narrowing and enlarging from place to place, creating fountain gatherings at the corners and giving rise to surprises with sudden chops and changes are the product of good and happy neighbourhood relations.

**Figure 5.** Row housing with bay windows (Author achieve, 2014).

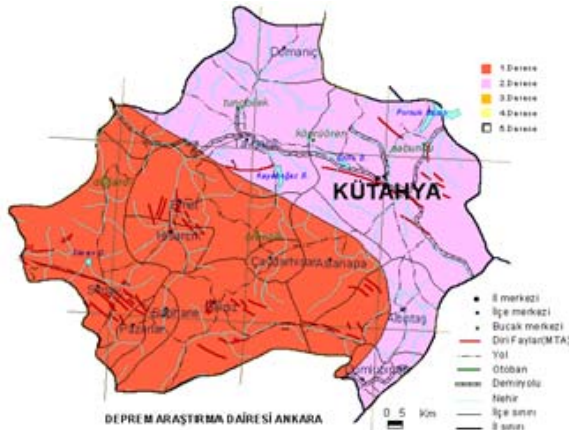
**Figure 6** .Kutahya regional earthquake map, Republic of Turkey Prime Ministry Disaster and Emergency Management Presidency Directorate General of Earthquake [4].

This map was prepared with the help of present information and entered into enforce in accordance with the decision of the Council of Ministers dated 18<sup>th</sup> April, 1996 and numbered 96/8109. Different from the previous maps, earthquake zones were

determined on the basis of contour map which is drawn according to the probability calculus. According to this, it is estimated that a normal structure, with 90% probability, will not be exposed to a more loading than these acceleration values in its 50 year economic life. For important structures or the structures with longer economic life, the highest acceleration values that they may encounter need to be calculated.
